COUNTRY	USSR/Rumania	REPORT	
SUBJECT	Port Facilities, Installations, and Vessels Sighted in Black Sea Ports	DATE DISTR.	12 November 1957
		NO. PAGES	2 50X1-HUM
		REQUIREMENT NO.	
DATE OF INFO.		REFERENCES	
PLACE & DATE ACQ.			50X1-HUM

reports on Black Sea ports

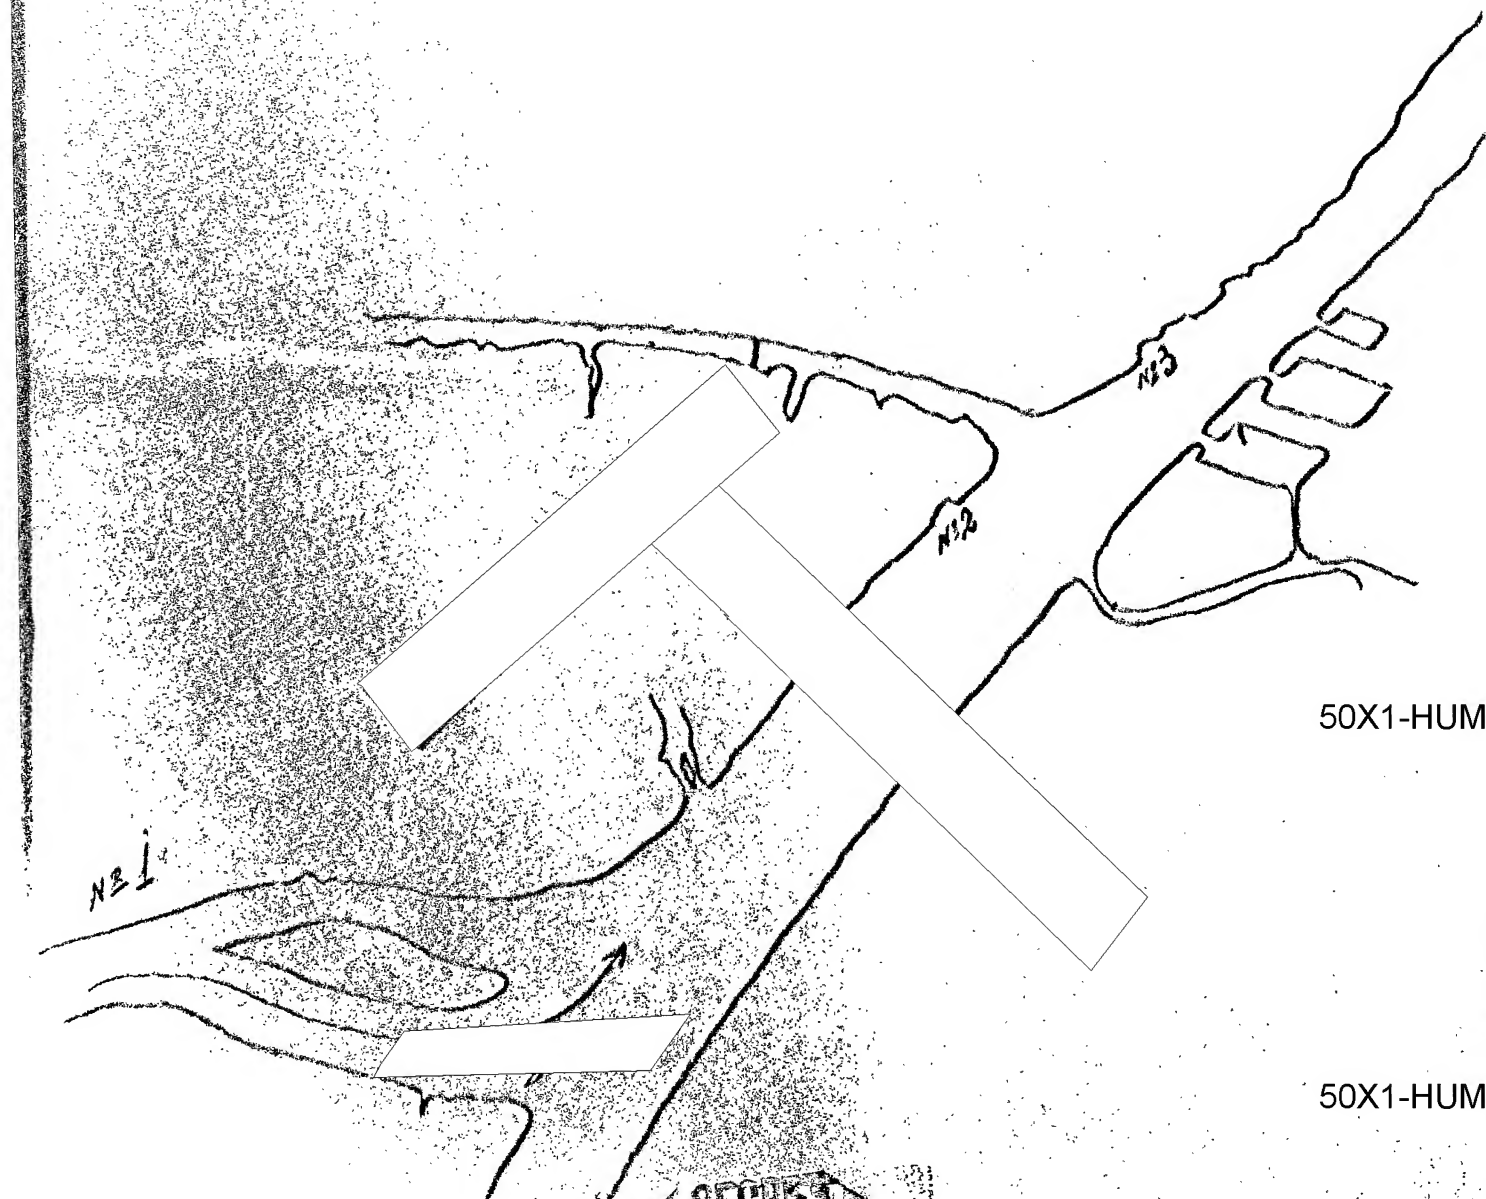
- 1- 20 oil tanks of medium size were observed here. They were about the size of those at Drapetsona. A small, wooden pier with 2-3 slips was observed in front of the oil tanks.
- 2- Two shipbuilding grids were observed ~~on the other side of~~ the shore. A ship was being built, (5-6000 tons) on the one on the right going up. Only the hold had been built. It had no superstructure. There was no ship on the grid on the left.

A crane located between the two grids which served both of them.

The direction of the drydocks create an impression because older information, (pictures) derive that the building slips are installed towards the direction of the current of the river and at its most southern point. It is probably that they may ^{be} the drydocks mentioned in a previous report which could have been changed over to shipbuilding.

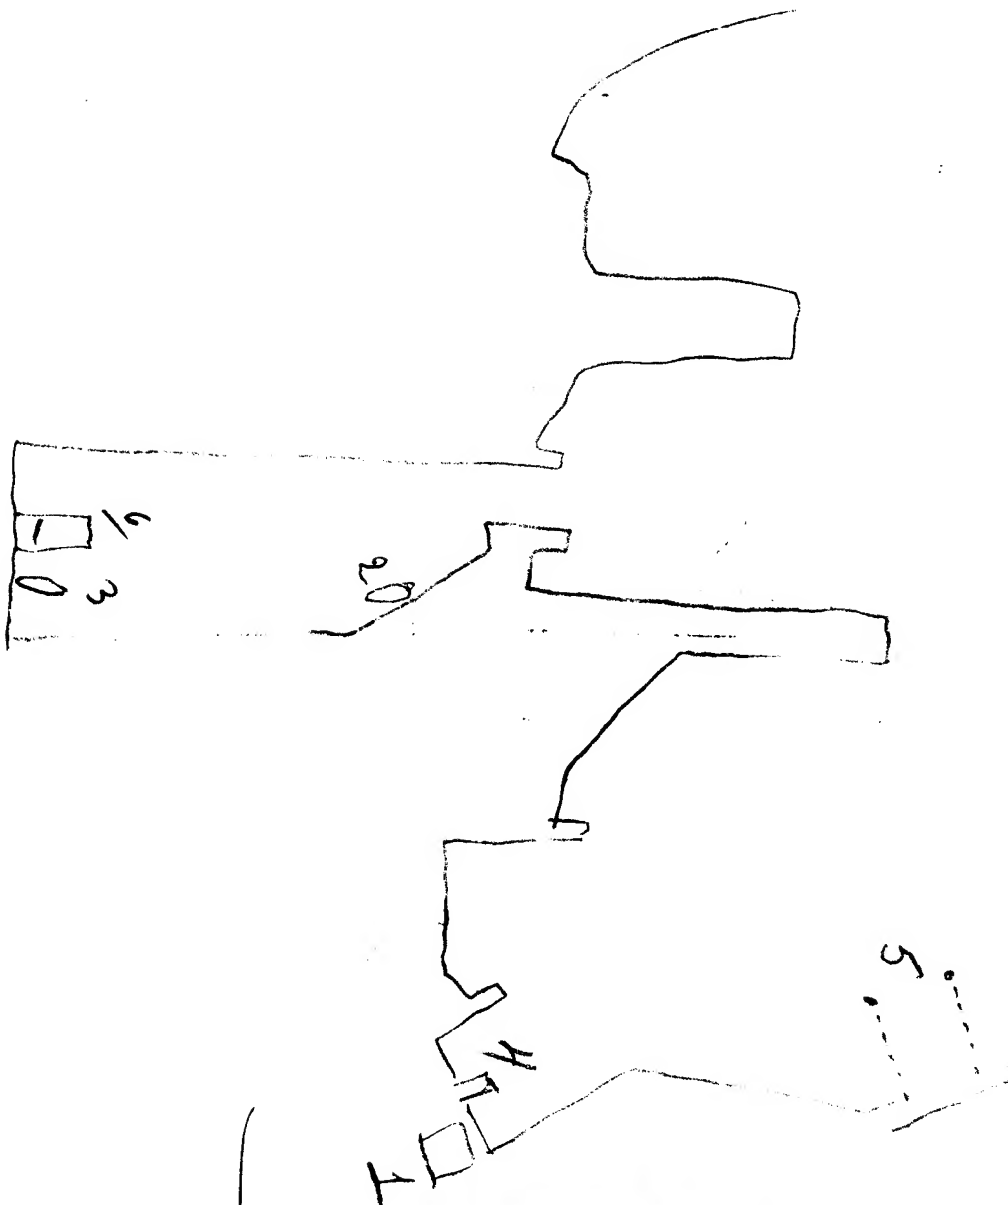
1. Location where the signal station is housed in a one-story, square building.

3. Location ~~where~~ ^{of} a moored destroyer

5. Two rows of barbed wire were observed in this area moored on buoys.

6. Location where a drydock is located. Two small warships were on drydock.

7. A vice type dredger was operating at this location which is the entrance to the port.

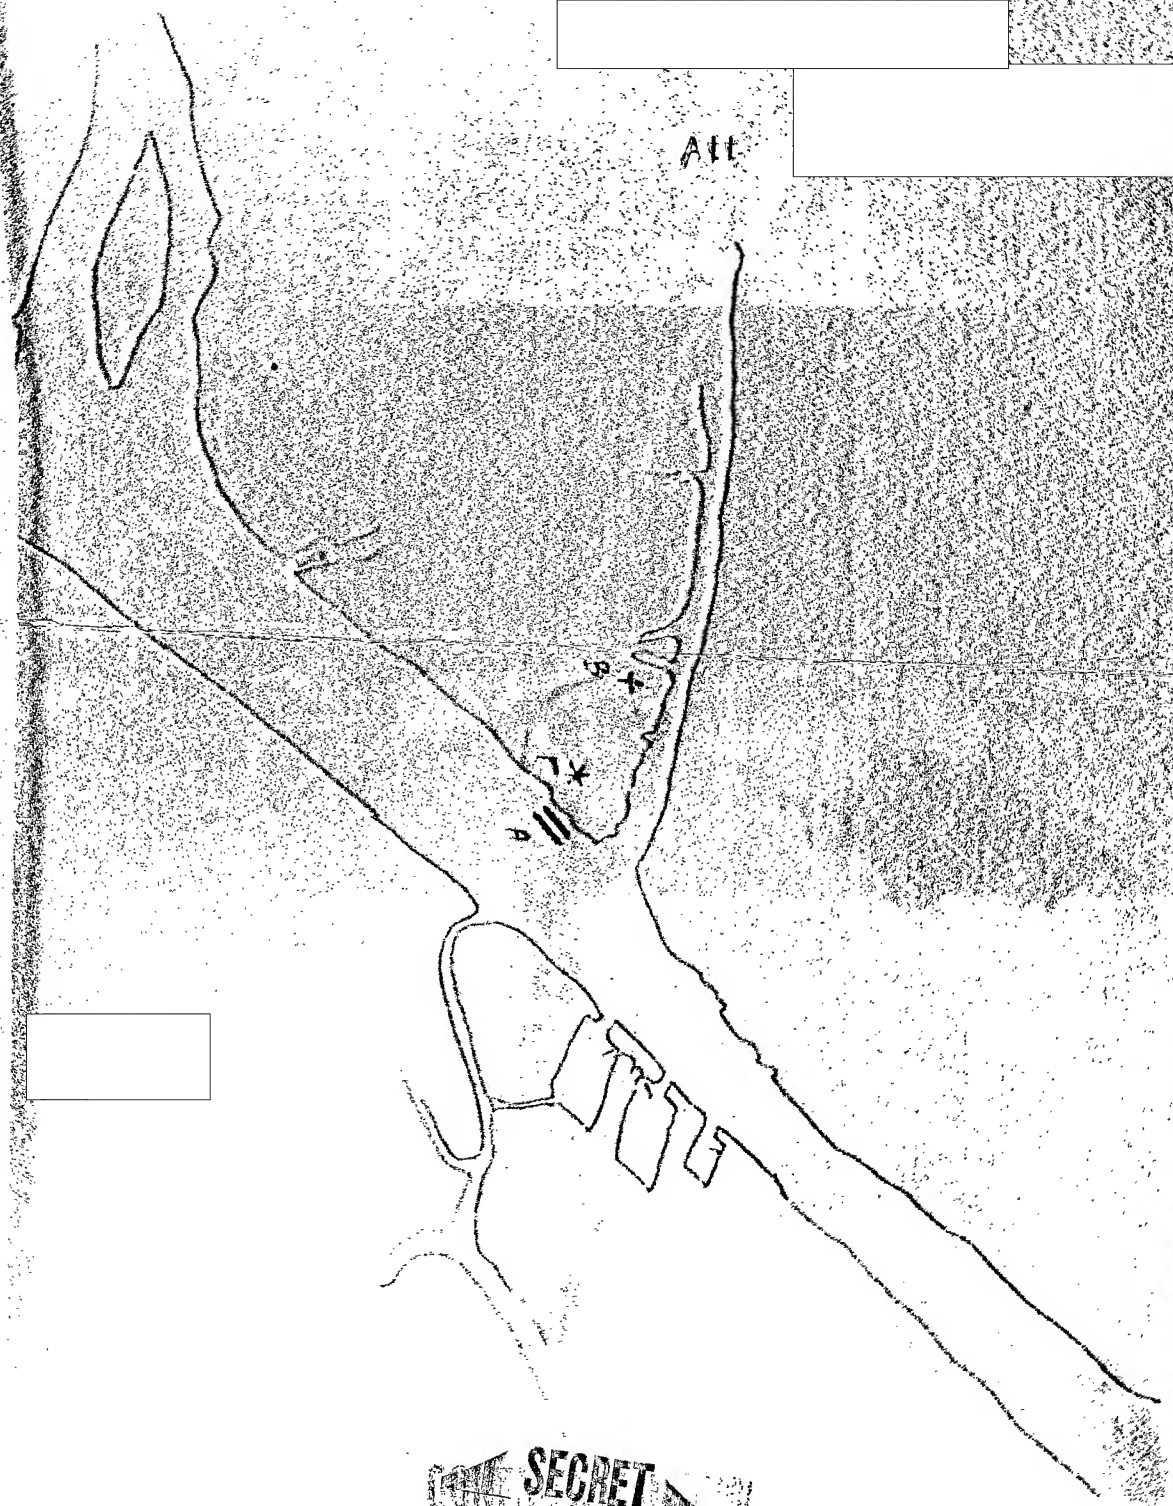
a) There were two cement drydocks docked at point "A". They were empty. The drydocks can take ships of 3000-4000 tons.

b) *A 10000 ton tanker is under construction at point "B" where there is a shipyard?*
x) [redacted] a shipyard is under construction at point "B".
